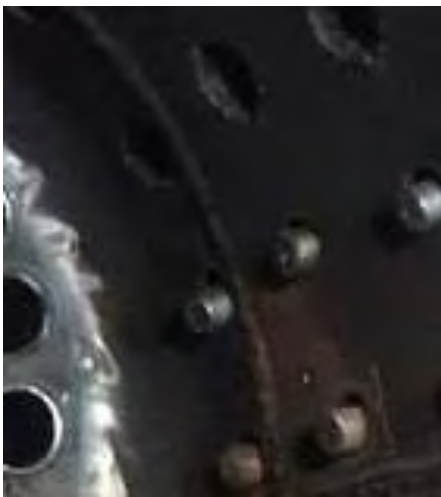
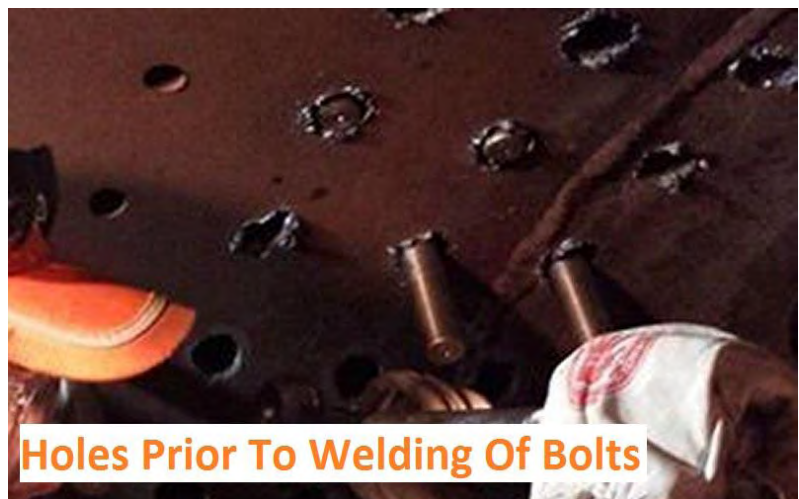
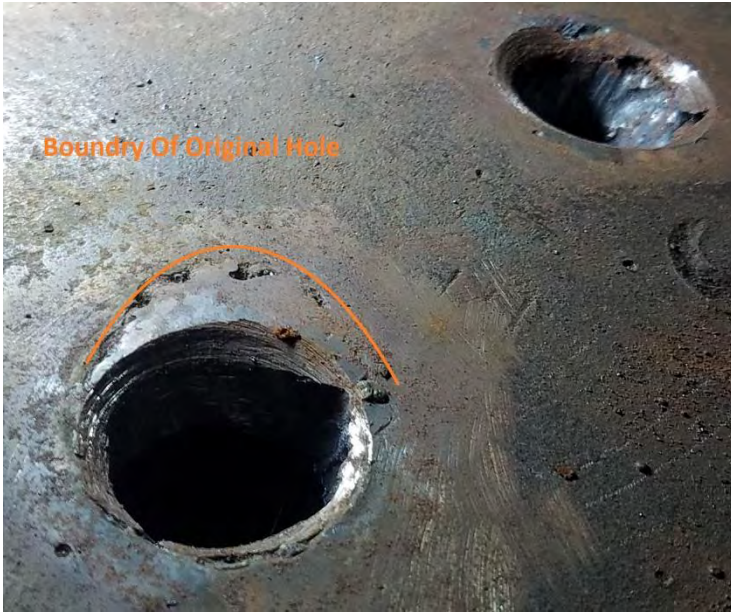
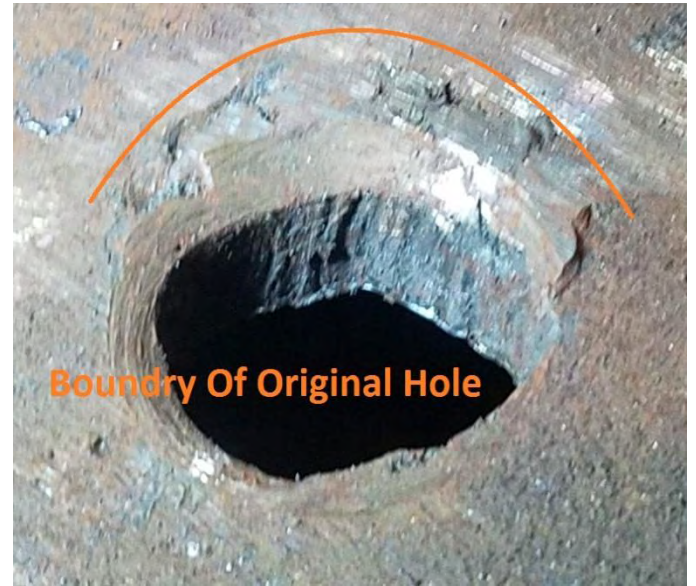
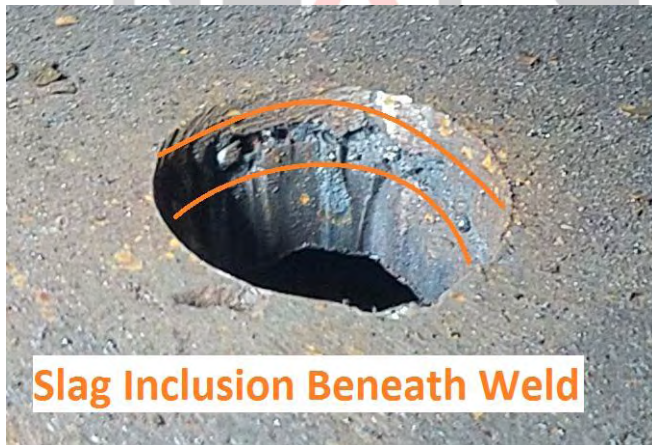
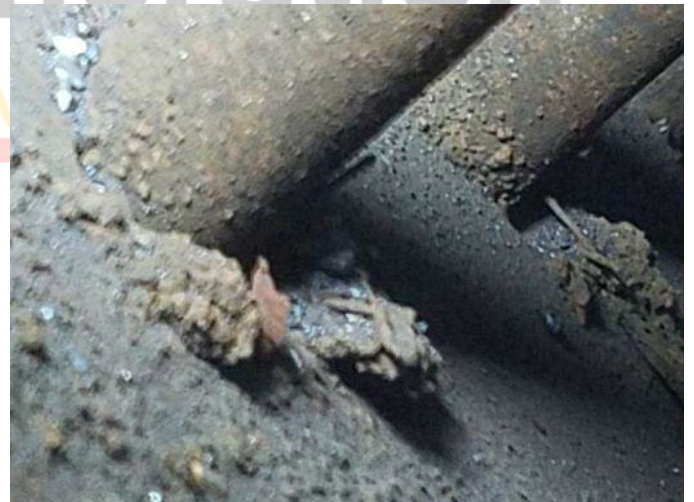
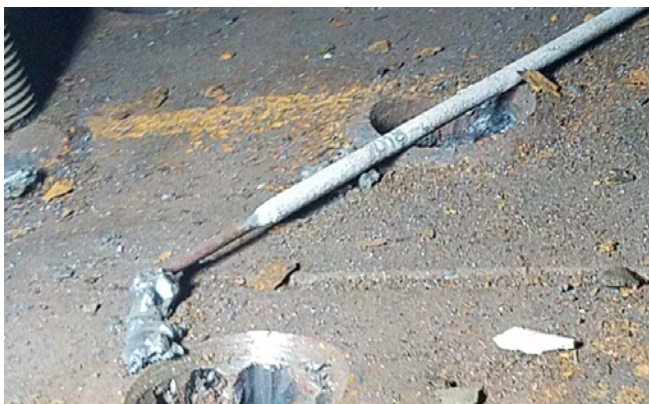
19) The First Three Rows Of The Crownsheet Bolt Holes

The first three rows of bolts had dramatically oversized holes (double bolt diameter, several of which are still visible. Those still visible are approximately 7/16" oversized. Approximately 18 bolts have been removed to allow for the weld build up of the holes. This was done so poorly that the original enlarged diameter is still visible at multiple locations as well as pockets of slag within the welds.

While it is unclear as to why, the water side surface of the sheet has been built up with weld. The thickness of the .375" sheet has increased to over .625". I conclude that this was done for the purpose of hiding sheet misalignment. The welding rod utilized for this welding is not appropriate for use on pressure vessels.

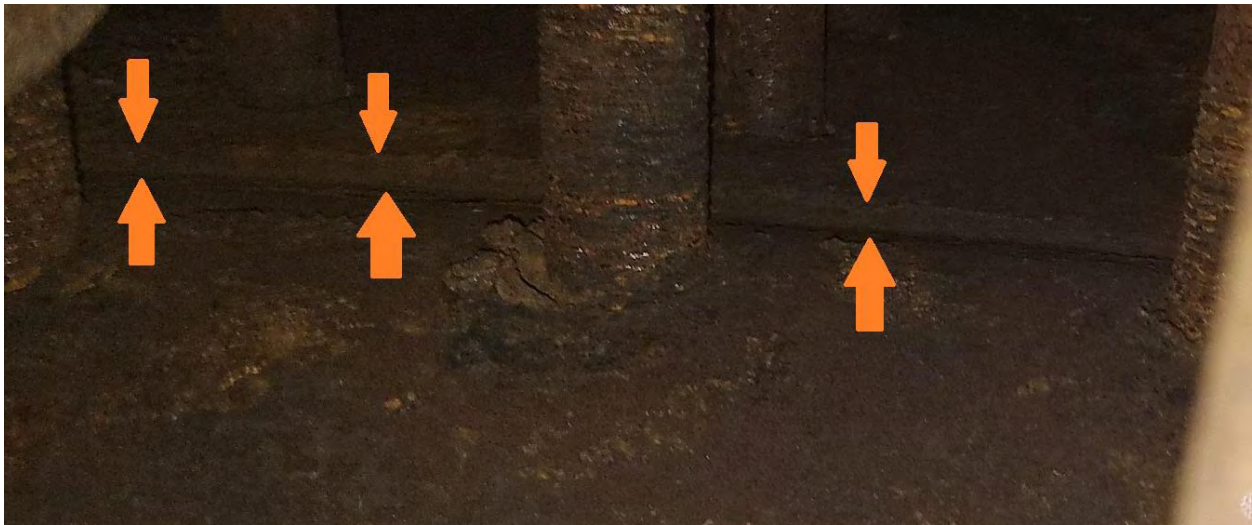
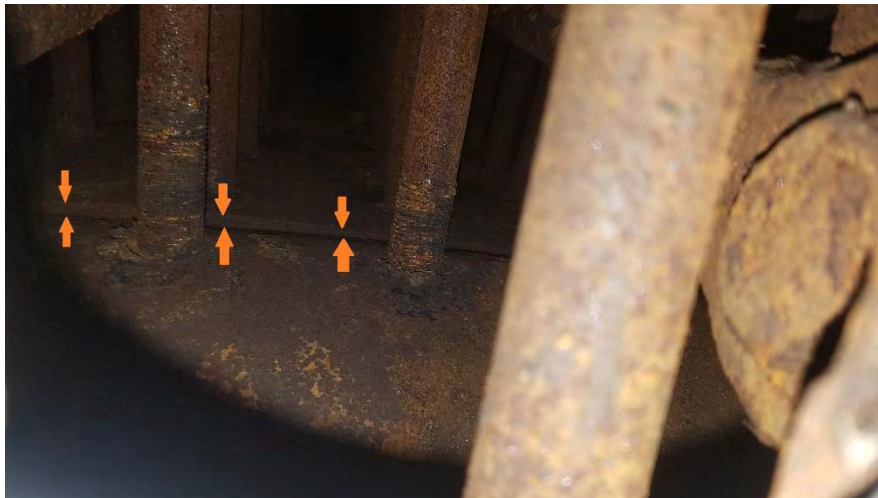
20) Crown To Doorsheet Fit-up

The welded joint between the crownsheet and doorsheet was found to be far in excess of ASME/NBIC parameters. These standards were discussed above regarding the corners. In addition to the sheet misalignment, the accompanying photo depicts torch cut holes, and threads present in the welds joining the bolts to the crownsheet.

What was unable to be adequately captured in photos is the amount of misalignment. At the center of the crownsheet it is as almost full sheet thickness. In order to achieve this fit up, only the leading edge of the doorsheet knuckle was bent upward. When the new sheet was made the knuckle was bent about 10 degrees beyond 90 to allow for fit up. Instead of just the leading edge, the

transition in alignments should have flowed back into the radius.
