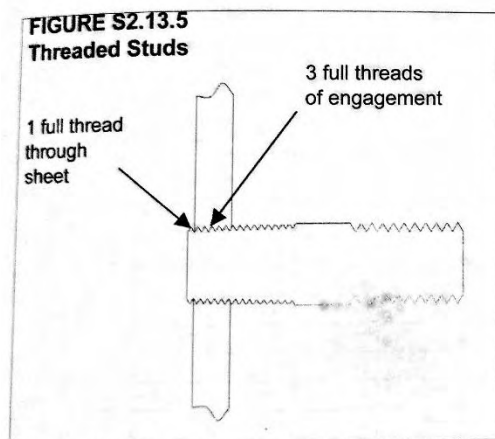
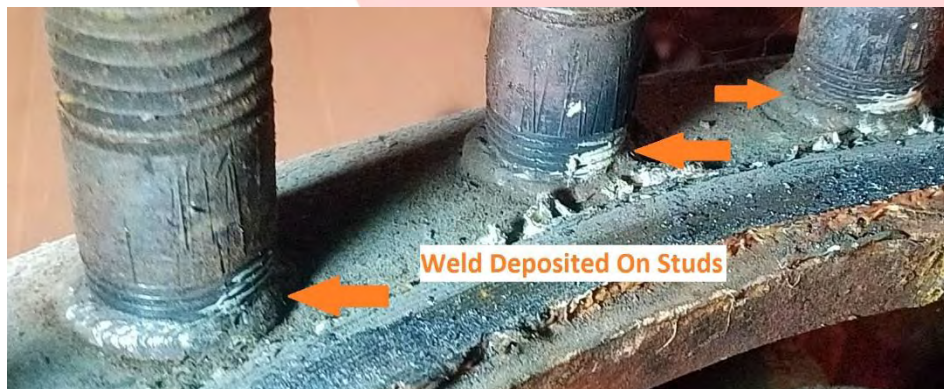
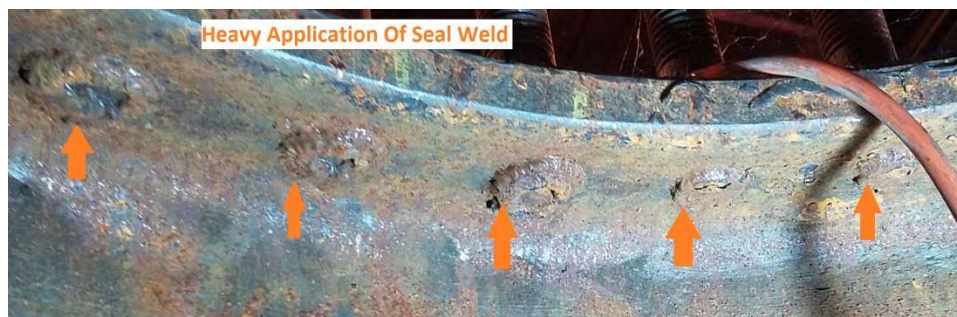
11) Dome Studs Welded

All of the dome studs have been seal welded in direct contradiction to NBIC Part 3 S2.13.5, the studs are no longer suitable for service. This in turn violates CFR49 Part 230.29 (b) (1).

- a) Studs threaded into the boiler or firebox sheets shall not be seal welded. (See NBIC Part 3, Figure S2.13.5).
- b) When studs are replaced, they shall extend at least one full thread through the sheet on the opposite side of installation. Replacement studs shall have a minimum of three threads of engagement.

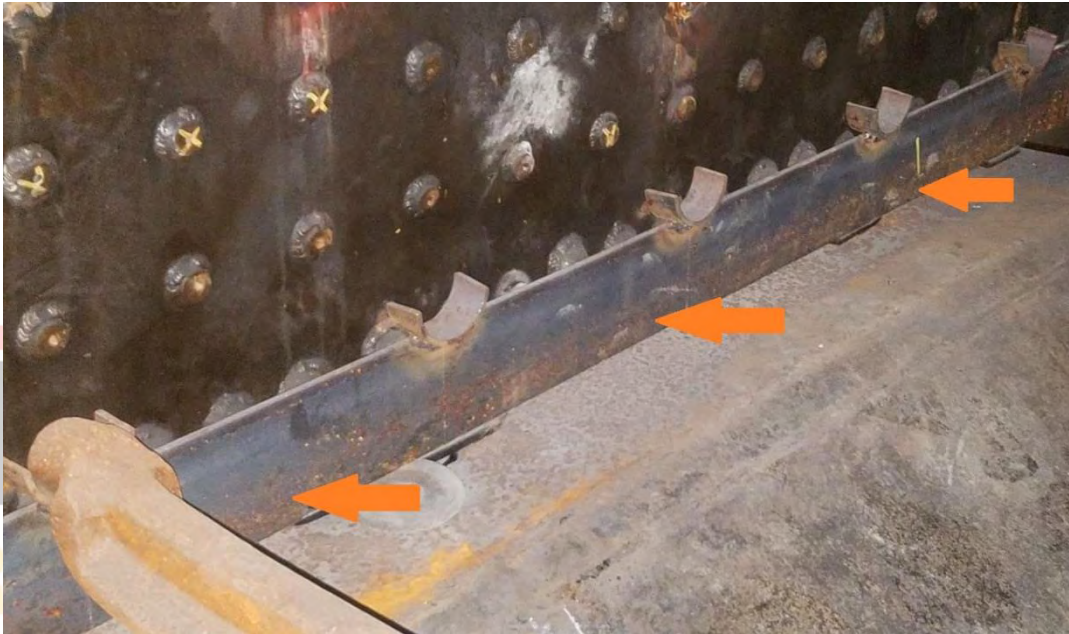
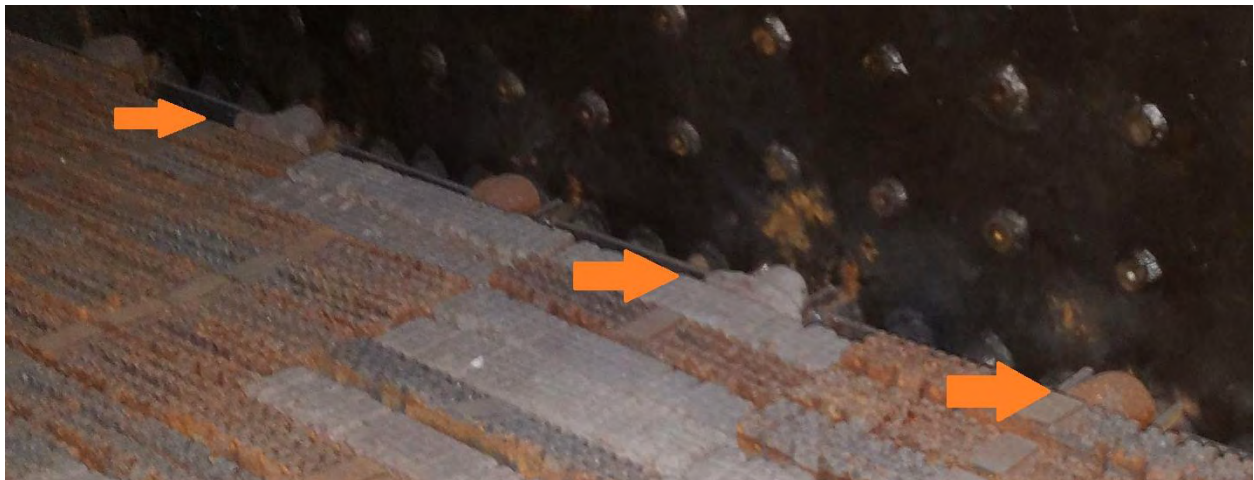
12) Side Grate Bearers

The side grate bearers consist of thin steel fabrications. Standard practice dictates these to be heavy/solid iron castings of an appropriate alloy. This is required as steel will burn, warp, and quickly fail.

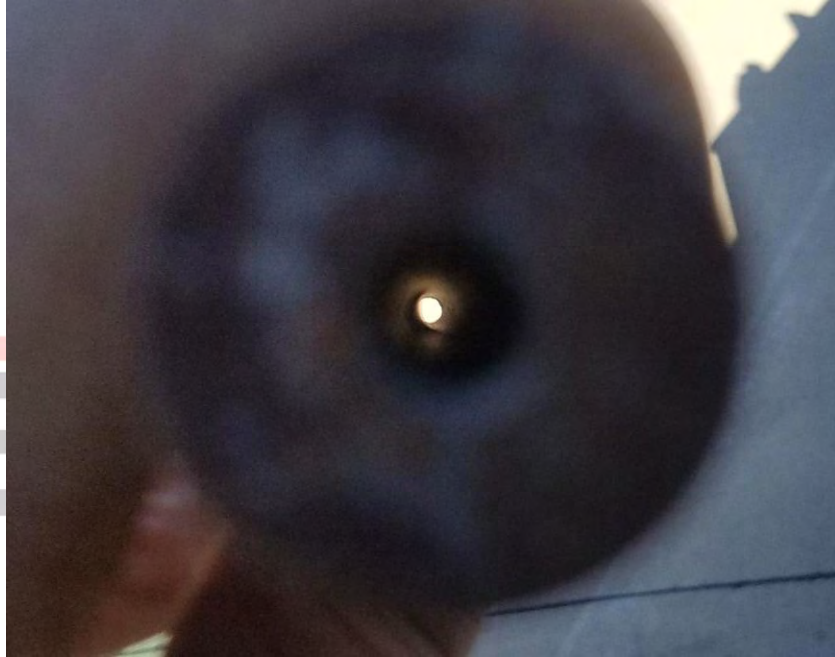
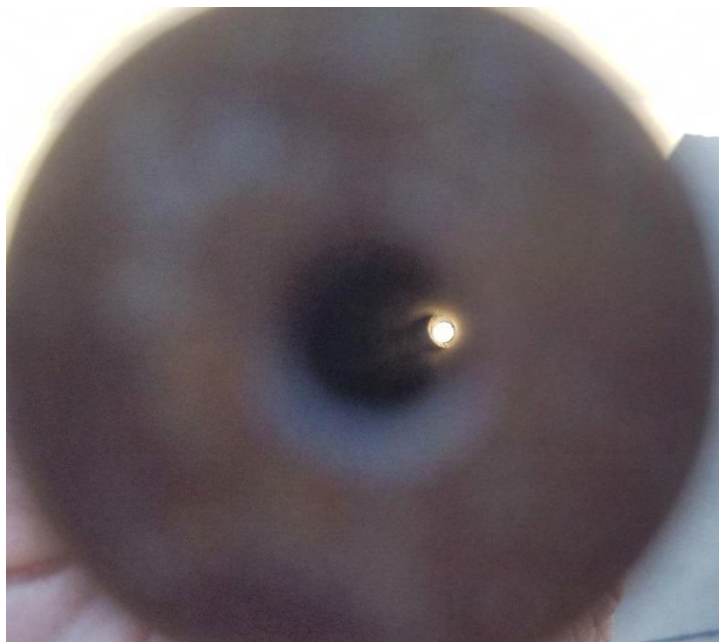
13) **Rigid Bolt Telltale Holes Drilled From Both Sides**

The telltale holes are drilled from both ends of the bolt, many do not lineup from one end to the other. Numerous bolts exhibit holes which are misaligned by $\frac{1}{2}$ of the hole diameter. This results in an inability to clear telltales in accordance with CFR 49 230.38 (c) as is evidenced by numerous broken drill bits left behind in the installed bolts. Bolts must be cleared so that when a bolt breaks, steam/water can be observed escaping.

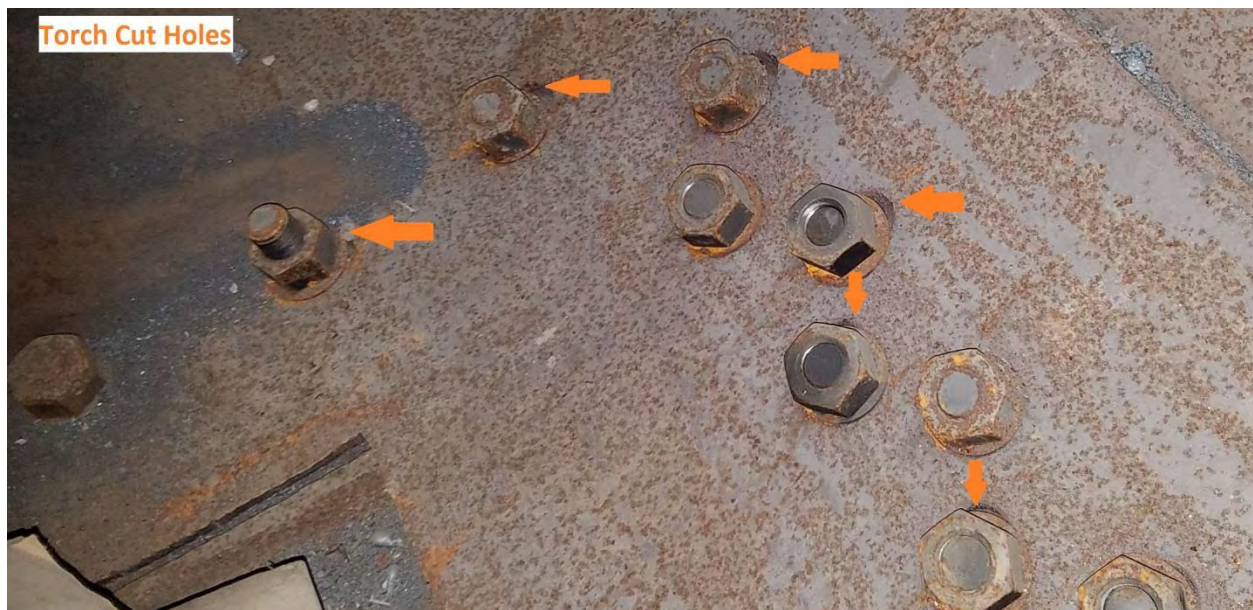
14) **Incorrectly installed Saddle Bolts**

The saddle bolts (bolts connecting the smokebox to the cylinder casting) are of incorrect design and installed incorrectly. Railroad standard practice calls for the saddle bolts to be of a taper fitted type bolt, these are commercially available, straight shank, black oxide bolts. The bolts were installed through dramatically oversized torch cut holes, versus the tight and machined fit standard practice calls for. Additionally, standard practice dictates that bolts be installed from the inside with nuts on the exterior, these bolts are installed upside down.

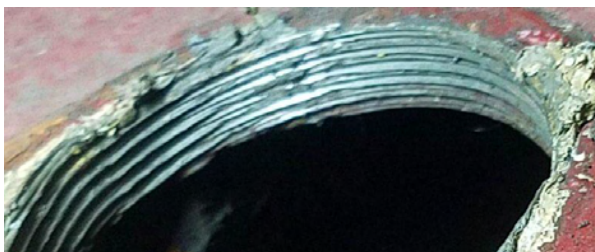
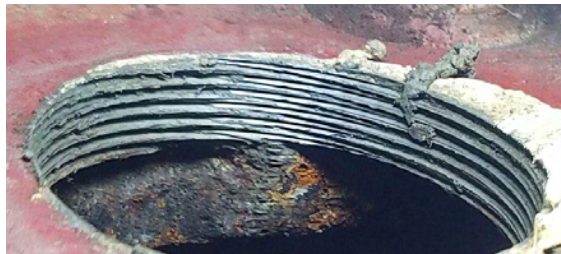
15) **Washout Plugs Of Incorrect Material, Holes Cross-Threaded**

All washout plugs are machined from a steel material. It is a well-accepted fact that steel plugs will seize in their threaded hole when utilized in locomotive boiler service, standard practice dictates the use of SB-61 bronze. Several holes are severely cross threaded.

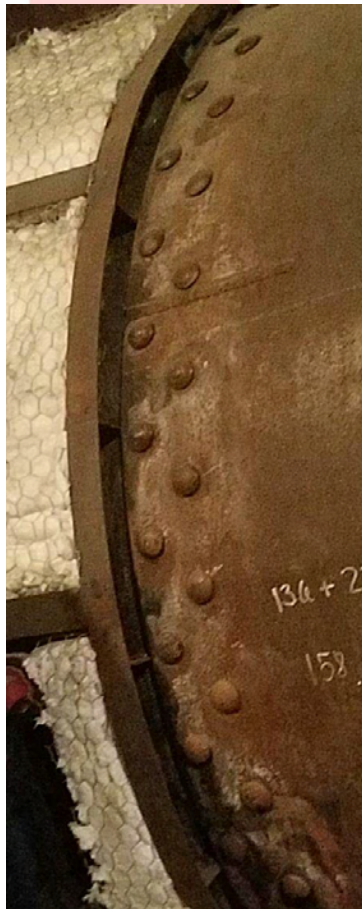
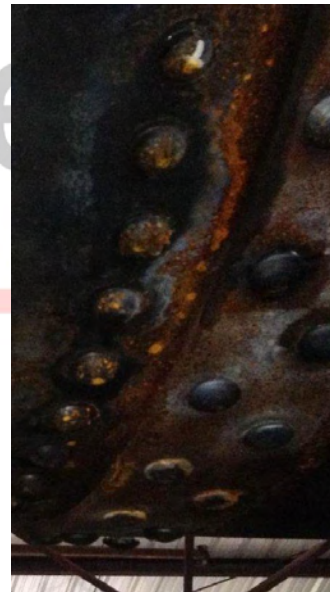
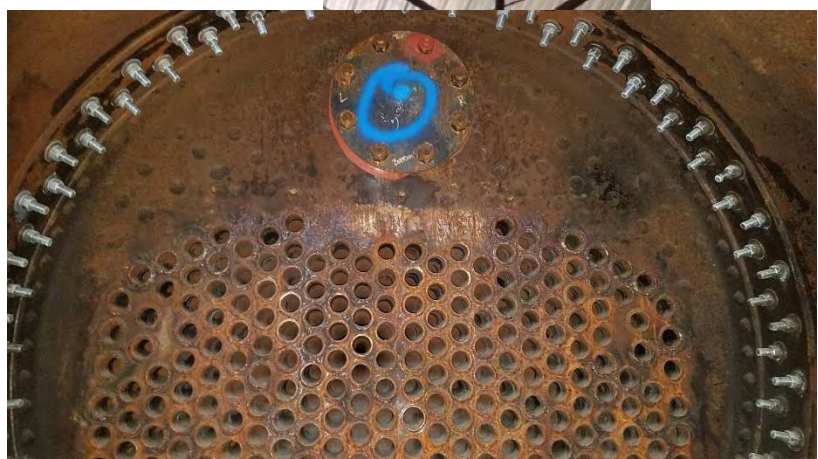
17) **Attachment Of Smokebox To Boiler Barrel**

The boiler and smokebox have been joined by generic/hardware store carriage bolts. Standard railroad practice calls for attachment via rivets. The exterior of the bolts were heated and driven with an air hammer, presumably to make them look more like rivets. This Joint will allow movement between the boiler and the smokebox which will ultimately lead to cracking in the frame.
