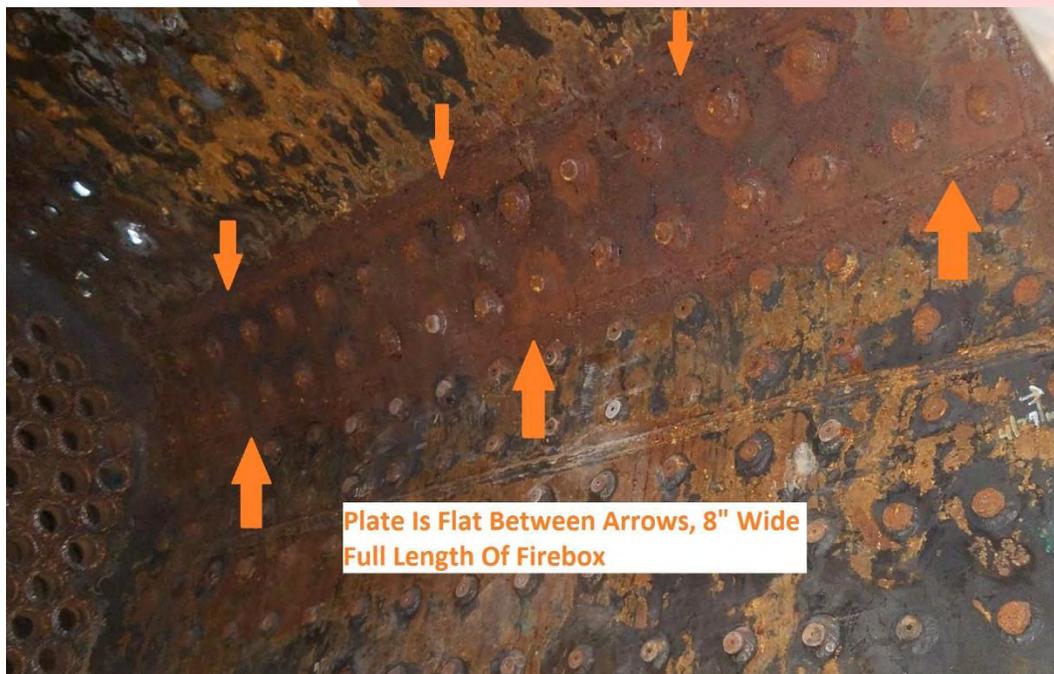
6) A Portion Of The New Firebox Was Replaced With Flat Plate In A Tight Radius

A sharply radiused portion of the new firebox was cut out and replaced with a piece of flat plate. This is contrary to O.E.M. design and violates railroad standard practice, and NBIC code. PW-9.3.1 states that the “middle lines” of the plate are to be aligned, these are not as one is radiused and the other straight. When replacing a portion of any boiler it is to be replaced “in kind” to the original. This in turn violates CFR49 Part 230.29 (b) (1).

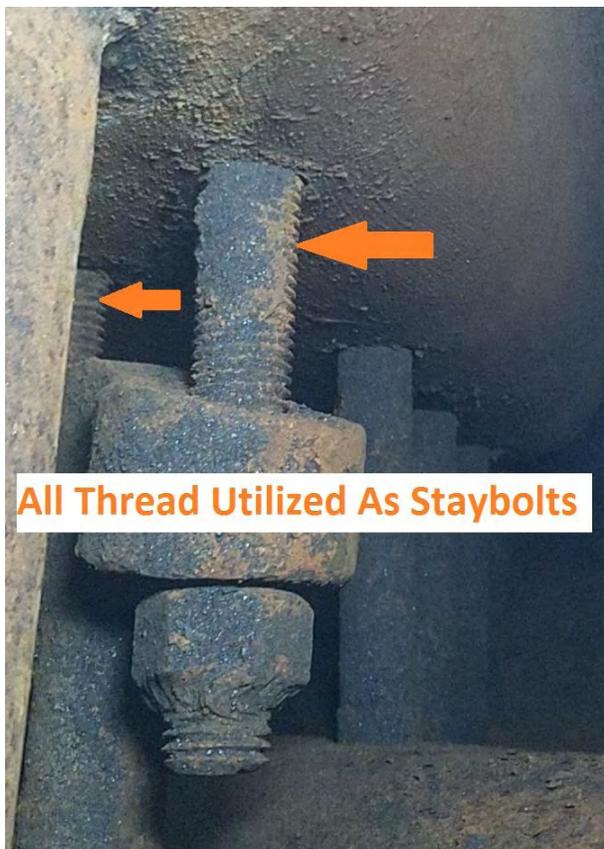
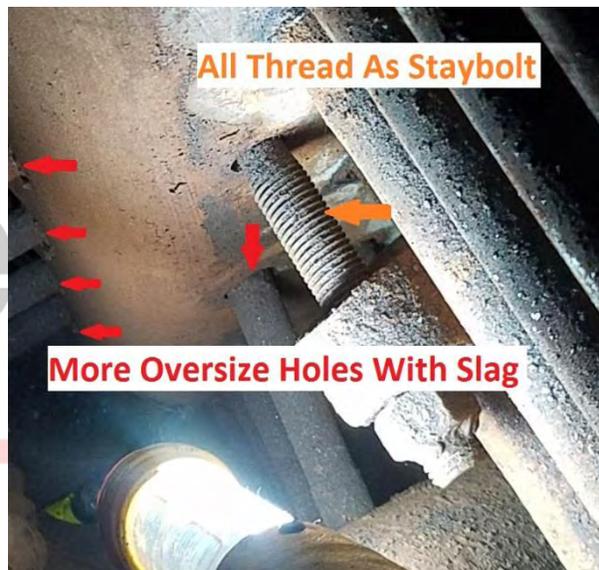
7) “All Thread” Utilized As Staybolt Material

All of the staybolts between the belly braces and rear tubesheet consist of an “all thread” material. ASME and NBIC specify that acceptable staybolt materials shall comply with SA36 or SA675. Commercially made “all thread” does not comply with either of these material specifications. This style of belly brace is designed to utilize a flexible staybolt, there is a socket beneath the nuts which do not generally contact the brace. This in turn violates CFR49 Part 230.29 (b) (1).

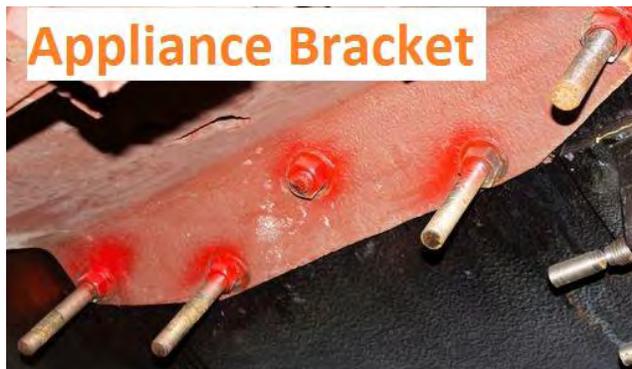
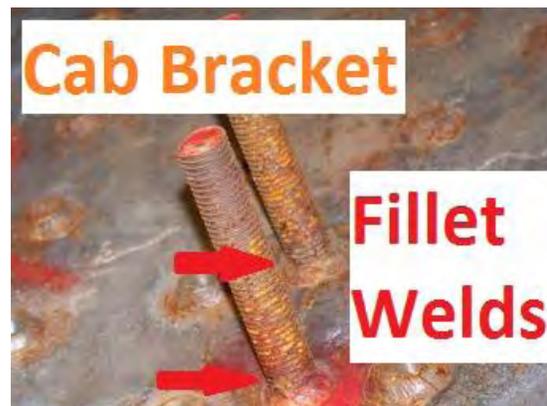
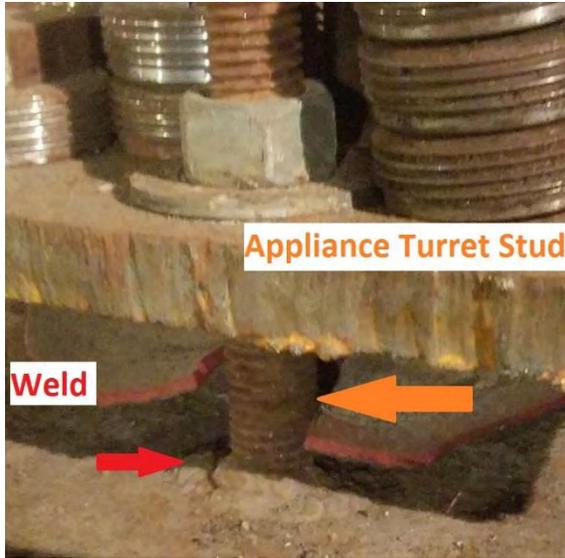
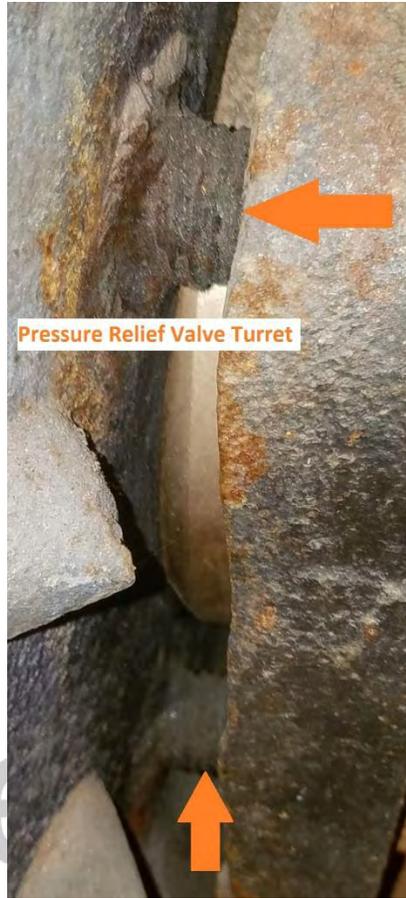
8) “All Thread” Utilized As Studs At 62 Locations Around The Barrel And Firebox, Installed Into Torch Cut Holes

A commercial grade “all thread” material was utilized. There are no commercially available “all thread” materials which are approved for welding into steam boilers. The pieces of “all thread” were installed into torch cut holes. Code does not allow for the welding of threads into a pressure vessel. This in turn violates CFR49 Part 230.29 (b) (1).

There are multiple locations around the pressure vessel at which these incorrectly applied studs are pressure retaining. These are especially concerning because when they do fail there would be a sudden and uncontrolled release of steam. Due to the proximity of the effected attachments to crew or the public, it is almost guaranteed scalding injuries would occur.

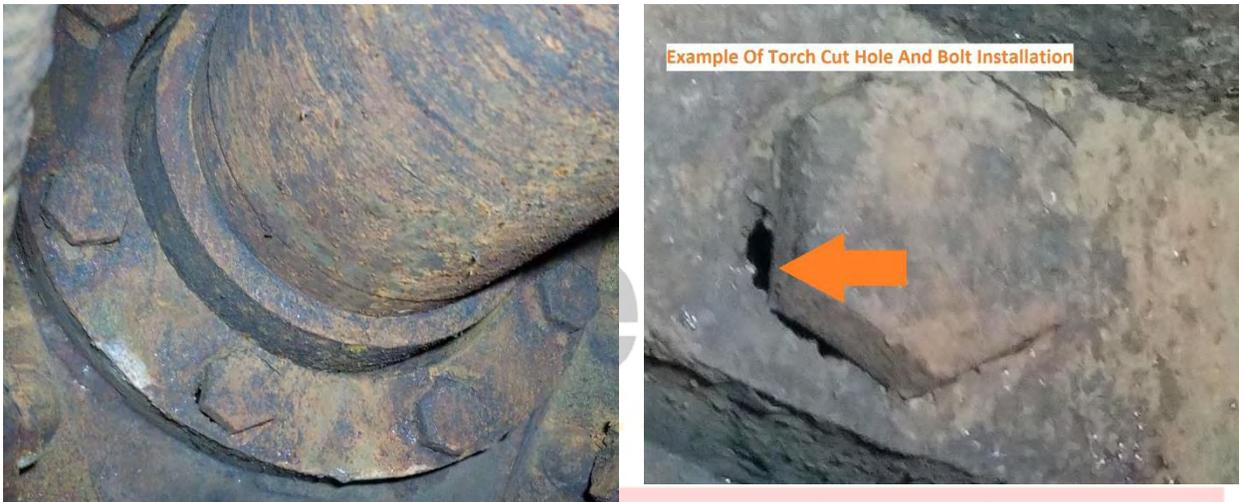
9) Bolts Welded Into The Vessel As Studs For Attachment Of Delivery Tee, Bolts Installed Through Torch Cut Holes

The issues with the bolts are no different than those of the studs, the use of bolts is not a compliant practice. The bolts are installed through torch cut holes, leaving behind gouging and striations. As discussed above, PW-29.3 prohibits these physical conditions. The integrity of the reinforcing ring has been compromised. This in turn violates CFR49 Part 230.29 (b) (1).

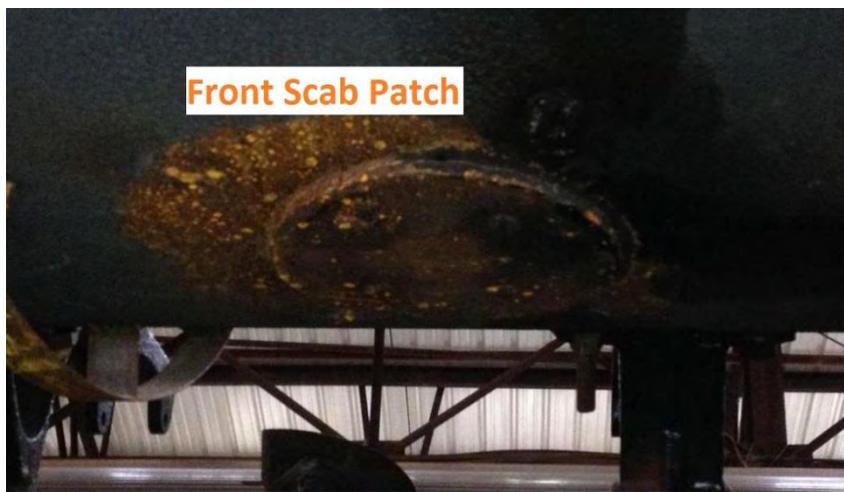
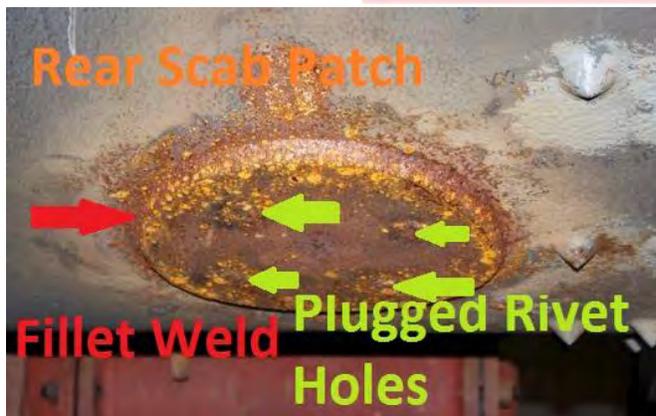
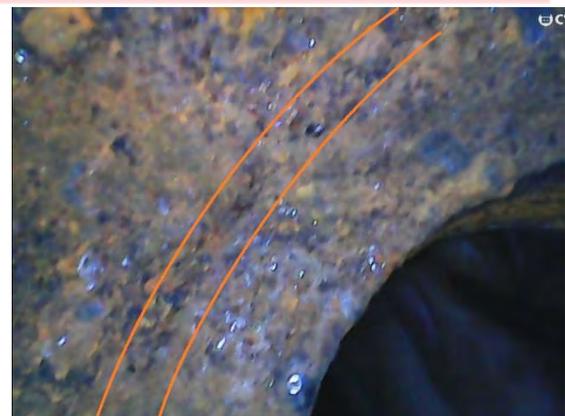
10) Non-compliant Application Of Nozzles And Scab Patches To Belly Of Barrel

Reinforcing liners for the application of washout plug sleeves were applied via fillet weld after the tubes were installed. Holes were then cut for application of the sleeves (referred to as nozzles), though the nozzles appear to have only been welded to the liner. This is determined via exterior inspection revealing inadequate beveling around the nozzle for full penetration 1 ¼" of material, and a borescope inspection which shows a seam on the waterside of the nozzle.

These conditions are in contradiction to PW-16.1

Orange lines show seam between nozzle and boiler barrel. This seam is large enough to show up through the thick layer of debris in the belly.
