K&T #14

Inspection Overview, Observed Defects & Corrective Actions

Jason Sobczynski
Next Generation Rail Services

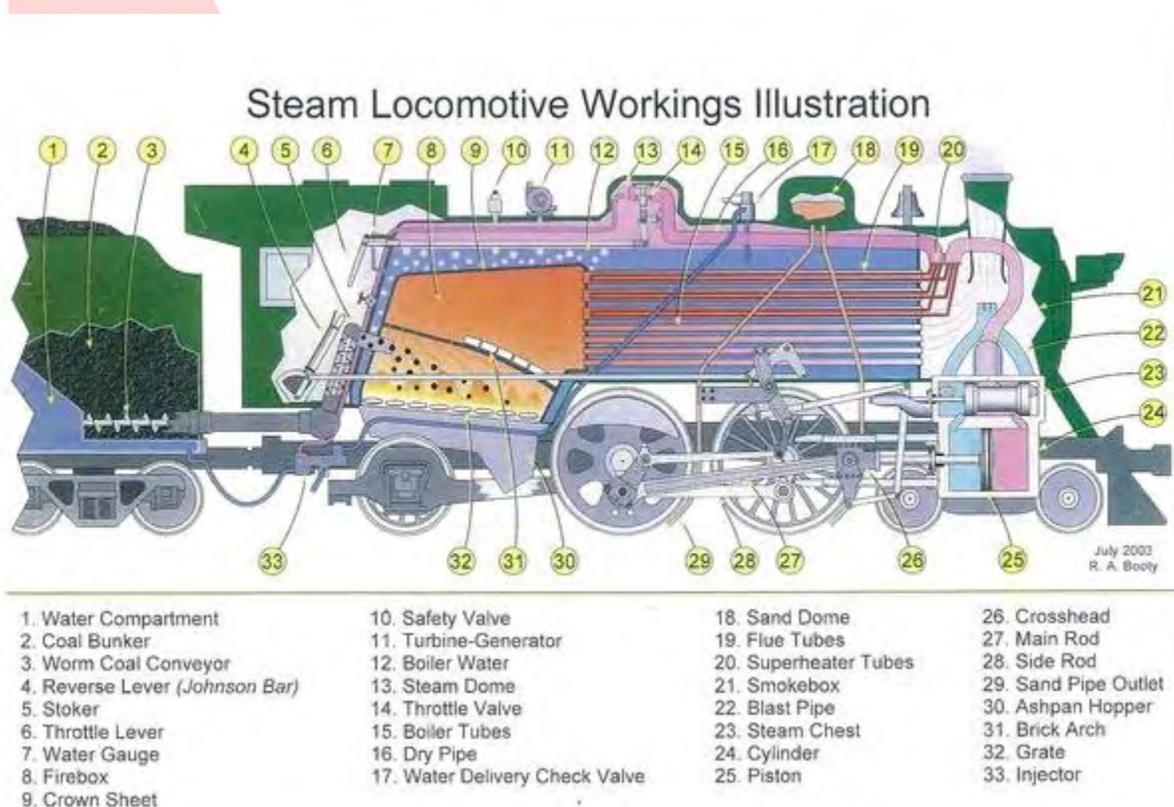
This image provides a perspective as to the manner in which the boiler is integrated into the locomotive.

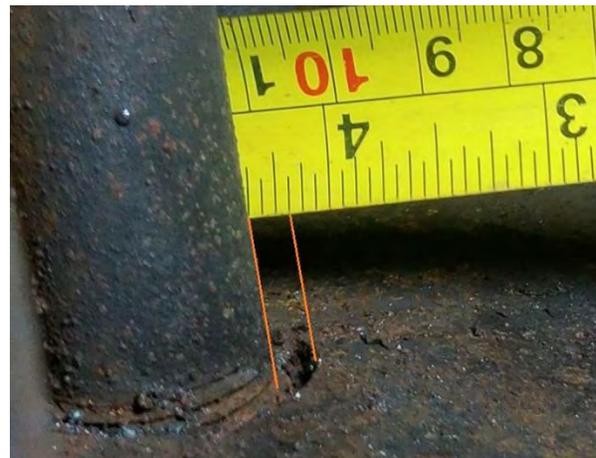
1) Rigid and Crown staybolts incorrectly installed.

The rigid bolts are installed utilizing a combination of fillet welding and threading. The FRA does not allow for the application of fillet welded bolts on non-chinese locomotives without prior written approval as it is not an accepted railroad practice nor (until summer of 2017) is it allowed by the ASME.

Though the ASME does now allow fillet welded installation, they must be applied under specific criteria as laid forth in PL-30. Specifically, parts PL-30.4, PL-30.4.2, and PL-30.4.4. This in turn violates CFR49 Part 230.29 (b) (1).

PL-30.4.2: A number of bolts do not have sufficient projection through fire side of the sheet to allow for 1/4" of weld without consuming the end of the bolt as prohibited by PW-19.2.

PL-30.4.4: All rigid and crown staybolts which can be observed from within the boiler have 1/8"+ clearance between the bolt and the sheet. Double allowable.

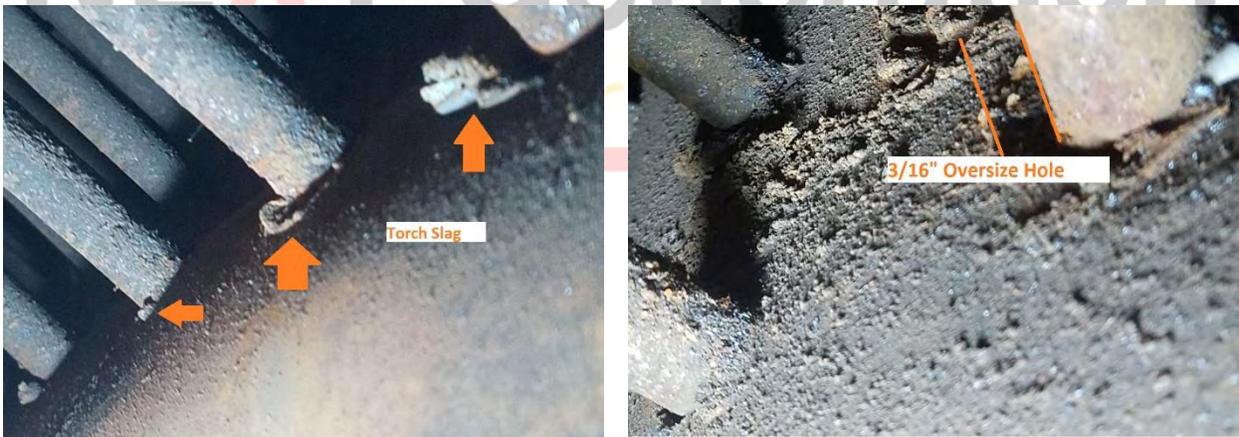
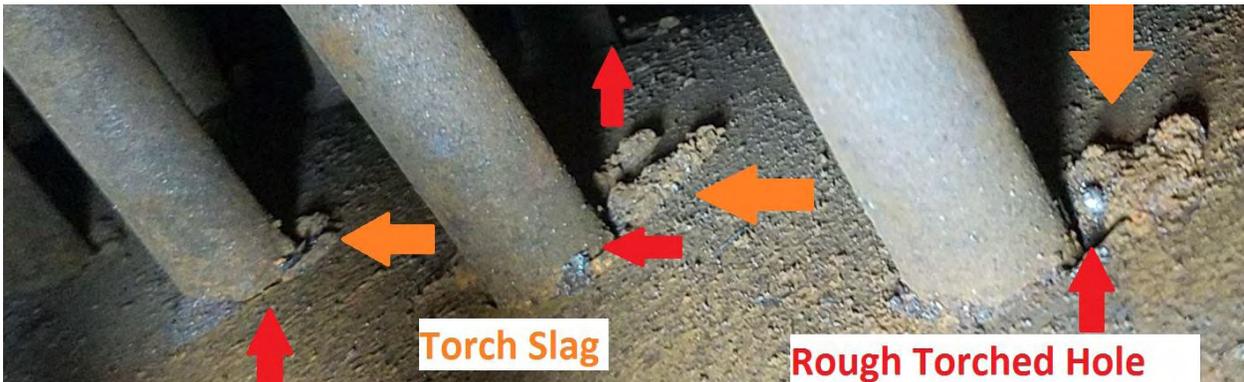
2) Flexible bolts installed via filet through torch cut holes which are between 1/8" to 5/8" oversized. This violates PL-30.4.4, and also PW-29.3.

PW-29.3: The surfaces left behind (throughout the firebox) by the torch cutting are not free of torch scale or slag (foreign material), and are also notched and consistently textured with deep striations. This in turn violates CFR49 Part 230.29 (b) (1). Hundreds such locations exist.

Orange denotes 2" diameter torch cut holes.

Red denotes holes in excess of 1/4" oversize in FR crown sheet

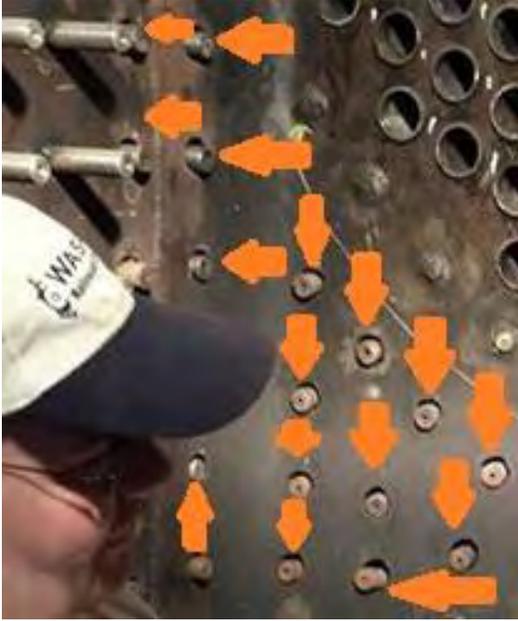
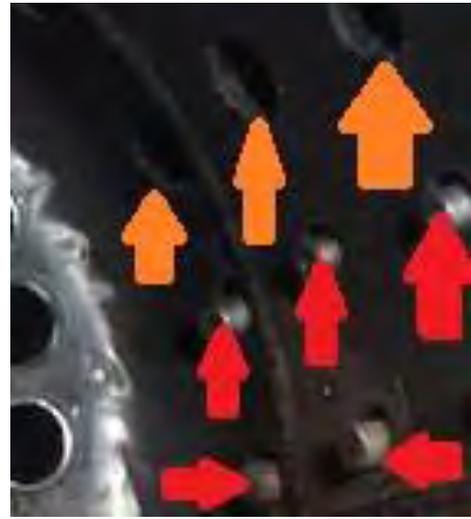
The above depicts holes well in excess of 1/8" oversize on fluesheet
