## GE 23 TON SWITCH ENGINE

### HISTORY

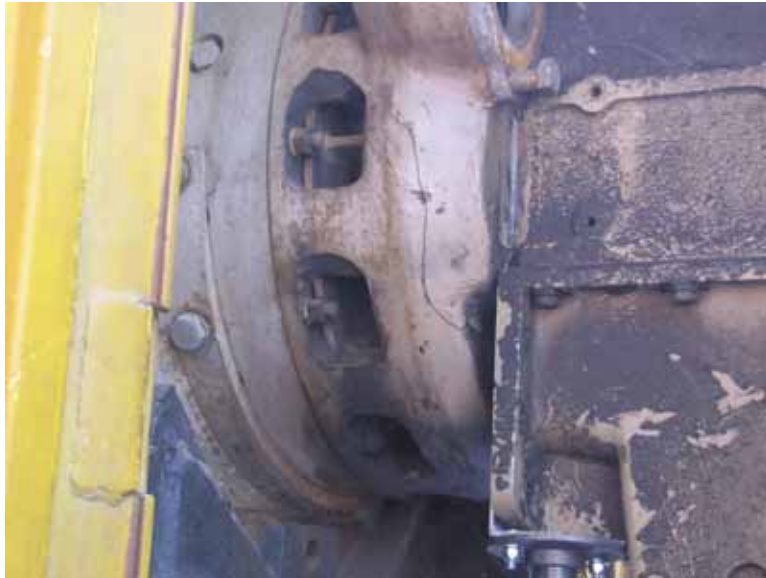
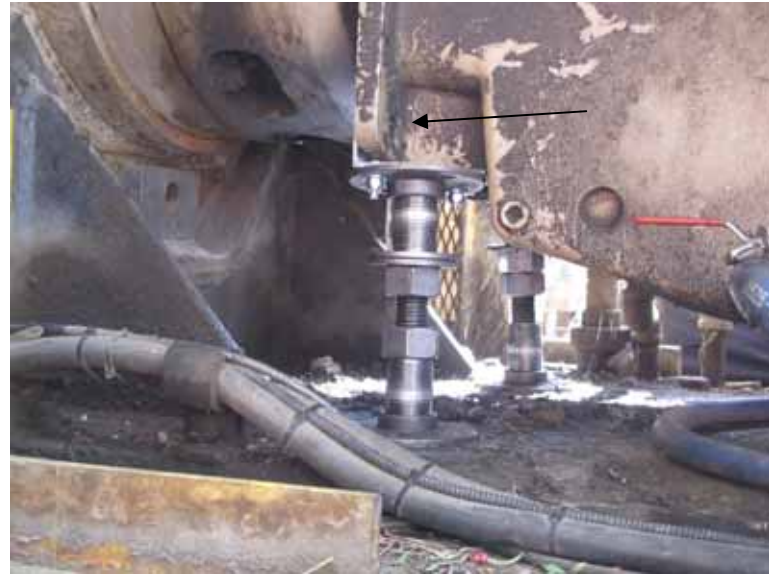
What we did was all well and good, but we had to face the biggest problem which was the cracked bell housing. Our analysis of the problem was that the diesel engine was supported at the front, but relied on the bell housing to provide support for the rear of the engine. The bell housing was cast iron,

and was not designed to handle that kind of stress, and eventually cracked on both sides, rendering the engine inoperable.

We also found a 9/16 inch hole in the back of the engine (arrow) to which we can bolt the brackets. We put a wrench on the back of the generator, and we were able to turn the engine. It did take a bit of effort, but we realized we were not only turning the engine crankshaft, but also the generator rotor!

We designed an adjustable support for the rear of the engine, and installed it temporarily for a fit check. The results were very encouraging, as the cracks in the bell housing closed up!

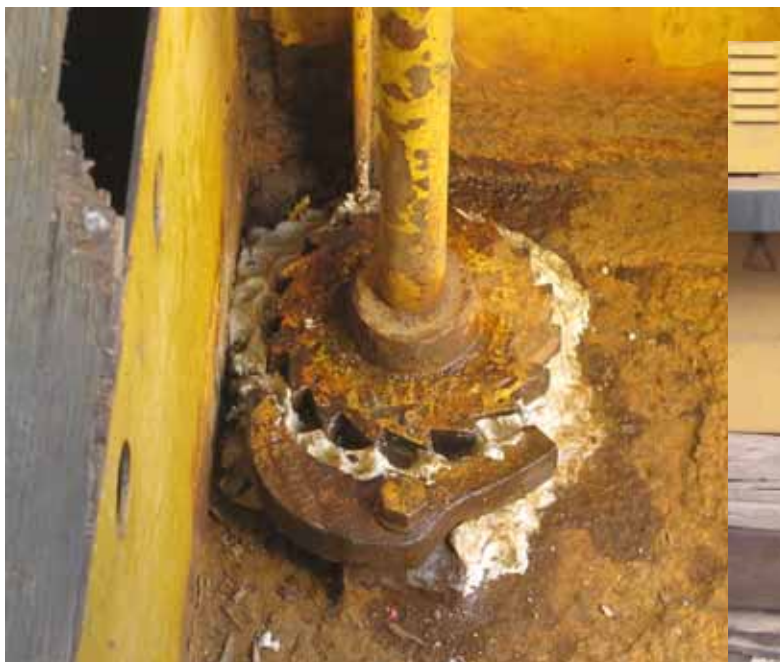
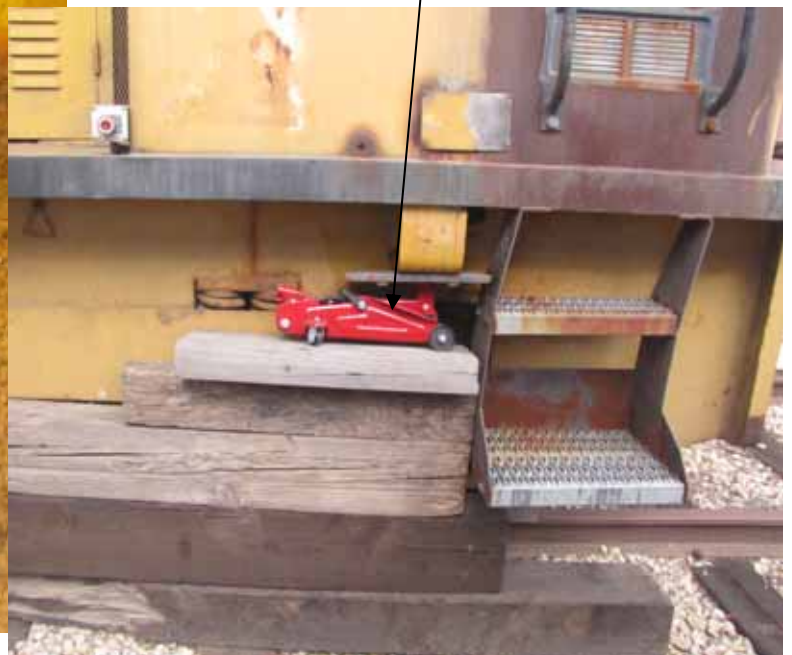
#### JACK

In the meantime, we attended to another problem brought on by the inactivity of the engine and the close proximity to San Francisco Bay. The hand brake next to the battery box was frozen with rust. We moved the pawl and wire brushed the area around the gear. We then built a dam around the gear with plumber's putty and filled it with penetrating oil. We wire brushed the underside of the shaft and the plate holding the end of the shaft. We also applied penetrating oil at both places. Our plan is to let it soak for a while then try to move the hand brake. We will also try jacking the shaft from the bottom to break it loose. If all else fails, we may have to use a torch.

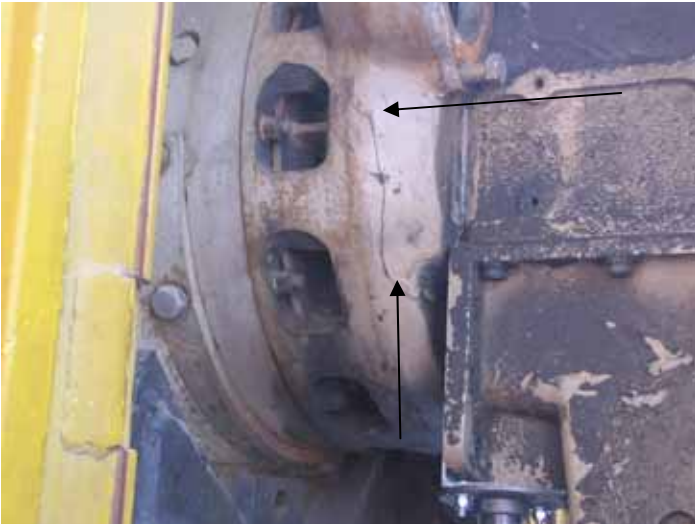
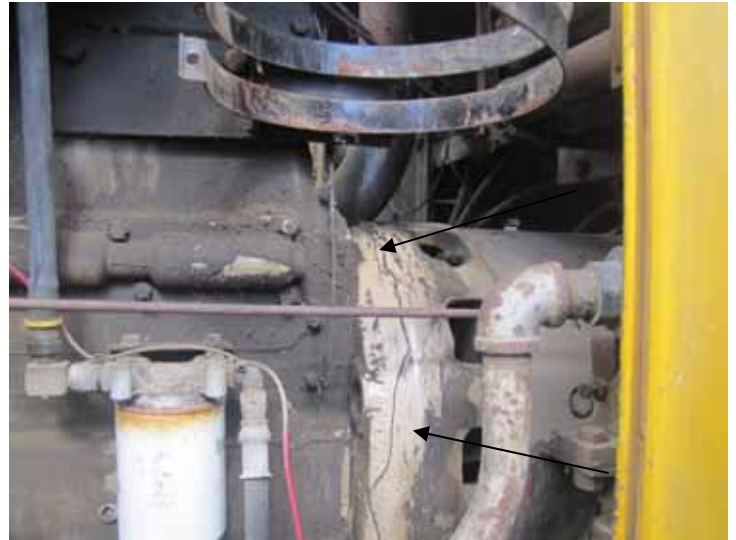
We sent the photos of the bell housing to Lock n Stitch to get a quote on them coming here and making a permanent fix. I received a response from Lock n Stitch requesting the length of the cracks and the material thickness. We made the measurements, sent the data to them.

We received a response that they were worried that someone had welded the bell housing and painted over the welds, and it hardened the cast iron so they could not drill it. They requested that we wire brush the areas to remove the paint and send them photos so they can see if it had been welded.

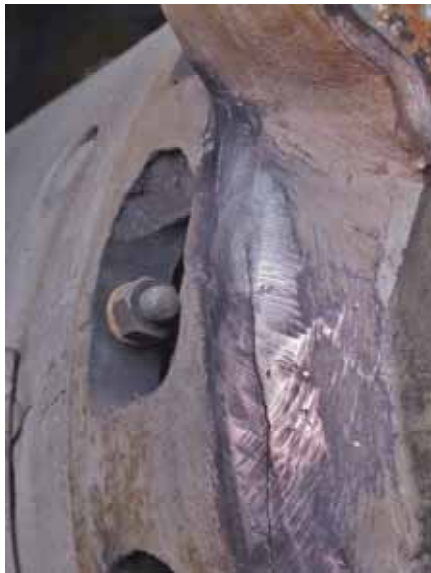
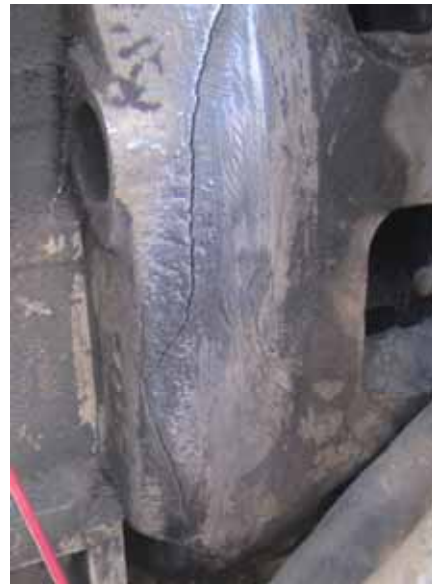
We wire brushed the areas with a wire wheel and were able to get some good pictures of the bare cracks. We forwarded the pictures to Lock n Stitch for them to give us an estimate.

We are looking at other methods of securing the cracks before we try to start the diesel engine. I have an idea for a much simpler version of what Lock n Stitch proposed.
